Manhole Inspection Summary

Manhole # S35S__021MH

Inspection ☐ Is Incomplete Rating: **3) Fair**

Location Address: **1313 marshall st**

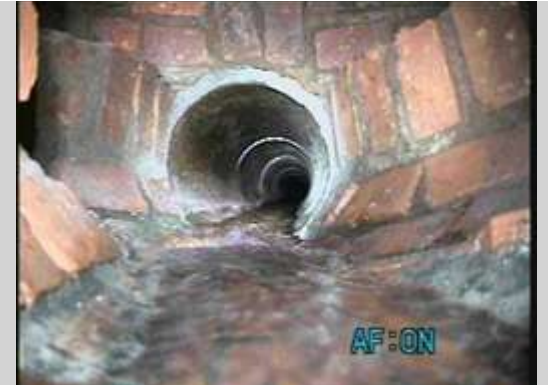
12 O'Clock Outflow

8 in. Circular Gravity Sewer
Pipe Out @ 12 O'Clock

Pipe Material: **Clay** ☐ Pipe Lined

Invert Depth: **9.90** (ft.) Flow Characteristics: **Fast**

Deposits: ☒ None ☐ Mud ☐ Sludge ☐ Debris ☐ Grease

Infiltration: **None** Pipe Seal Cond: **Unknown**

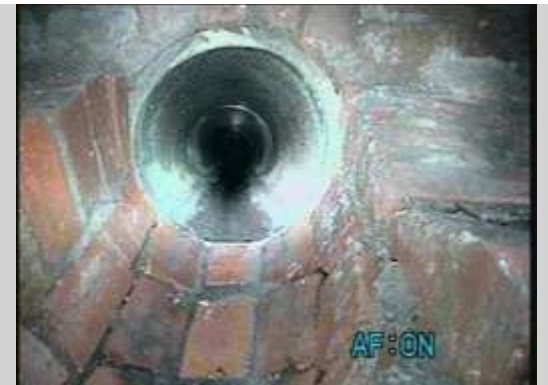
3 O'Clock Inflow

8 in. Circular Gravity Sewer
Pipe In @ 3 O'Clock

Pipe Material: **Clay** ☐ Pipe Lined

Invert Depth: **9.20** (ft.) Flow Characteristics: **None**

Deposits: ☒ None ☐ Mud ☐ Sludge ☐ Debris ☐ Grease

Infiltration: **None** Pipe Seal Cond: **Unknown**

Connects To: **House connection / Service line**

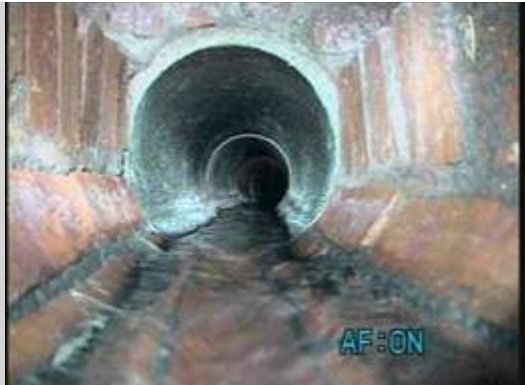
6 O'Clock Inflow

8 in. Circular Gravity Sewer

Pipe In @ 6 O'Clock

Pipe Material: **Clay** ☐ Pipe Lined

Invert Depth: **9.70** (ft.) Flow Characteristics: **Fast**

Deposits: ☒ None ☐ Mud ☐ Sludge ☐ Debris ☐ Grease

Infiltration: **None** Pipe Seal Cond: **Unknown**

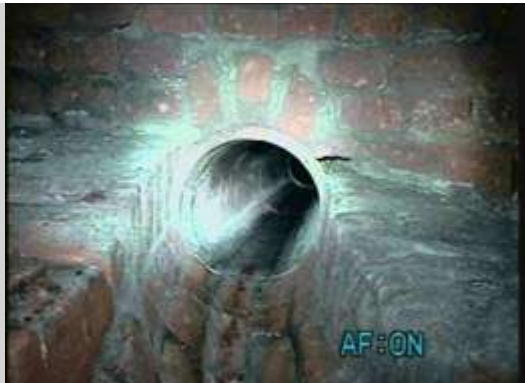
10 O'Clock Inflow

8 in. Circular Gravity Sewer

Pipe In @ 10 O'Clock

Pipe Material: **Clay** ☐ Pipe Lined

Invert Depth: **9.30** (ft.) Flow Characteristics: **Slow**

Deposits: ☒ None ☐ Mud ☐ Sludge ☐ Debris ☐ Grease

Infiltration: **None** Pipe Seal Cond: **Unknown**
